Groundwater Assessment Report

Yonge Subway Extension Project
Train Storage Facility
Environmental Project Report Addendum

Richmond Hill, Ontario

Prepared For: Toronto Transit Commission
and York Region Rapid Transit
Corporation

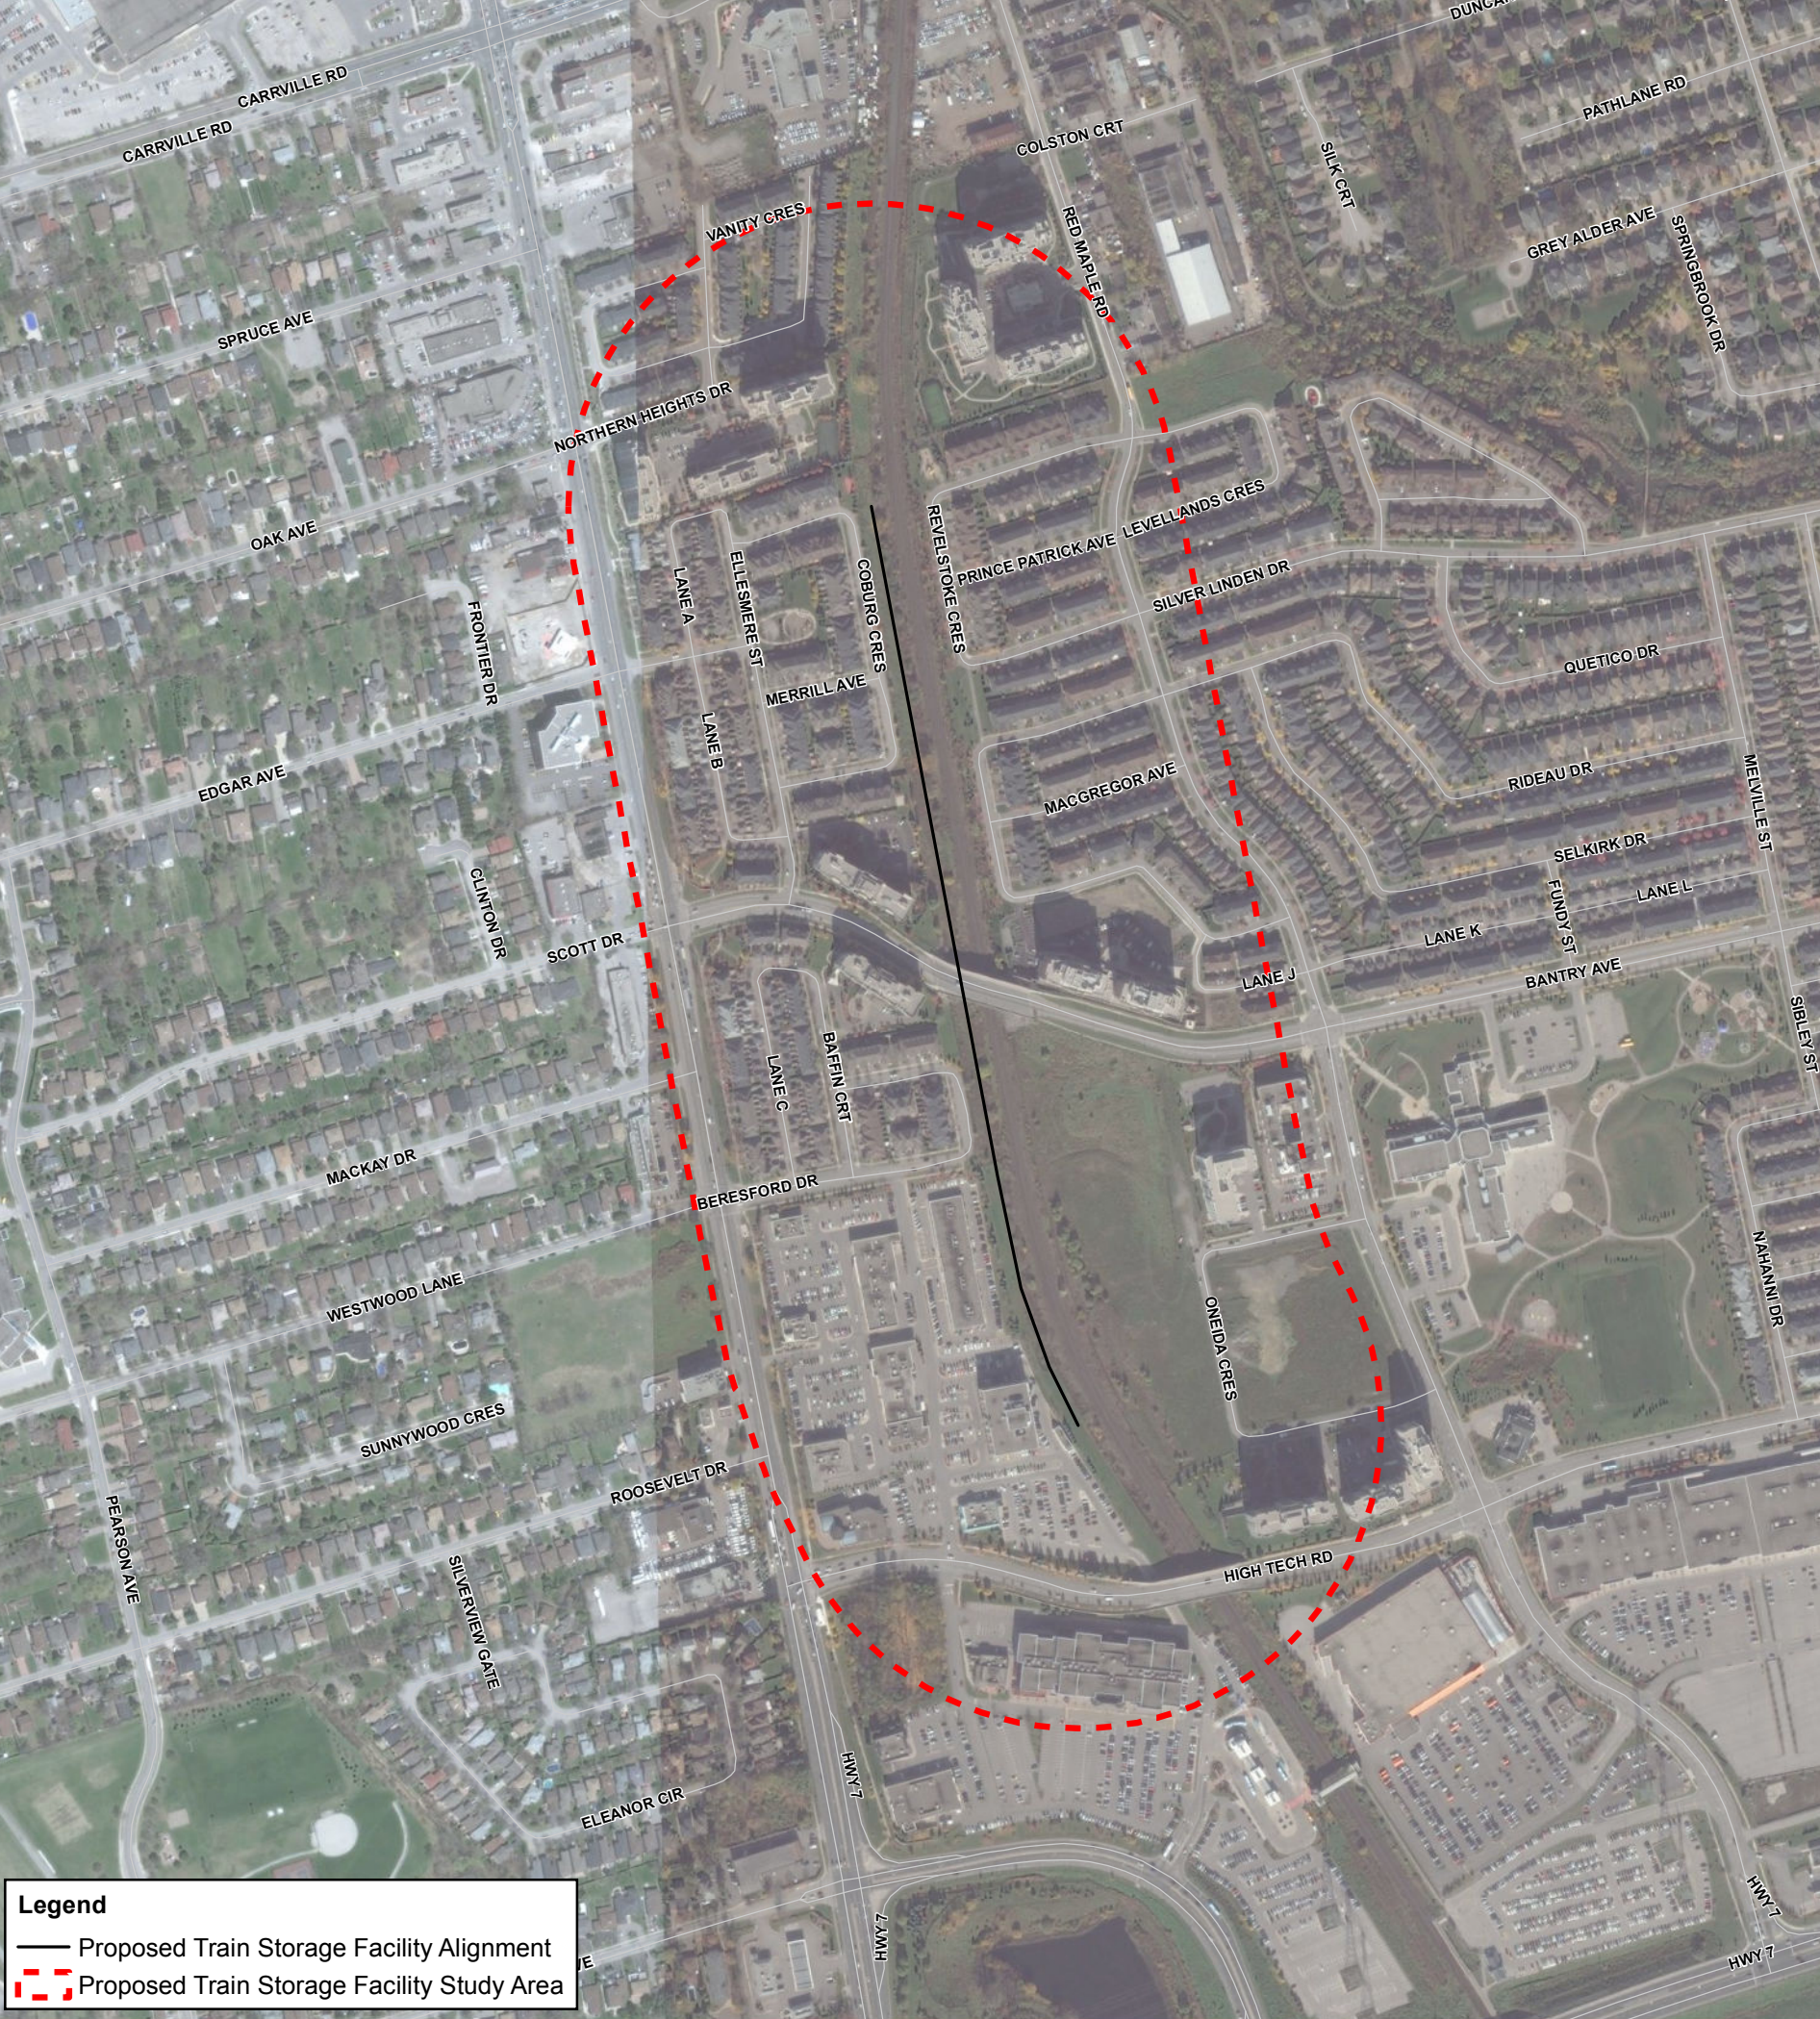
FIGURE
 1

Current land use within the Study Area is predominantly residential and commercial. Low-density with occasional high-density residential land use is present primarily in the central and northern portions of the Study Area, to the north of Beresford Drive and Bantry Road. Commercial land use is present as businesses in the southwestern portion and along the western boundary of the Study Area. Medical offices can be found in the southeastern portion of the Study Area. Office buildings are present in the southwestern portion of the Study Area. Land uses surrounding the Study Area are shown in **Figure 1**.

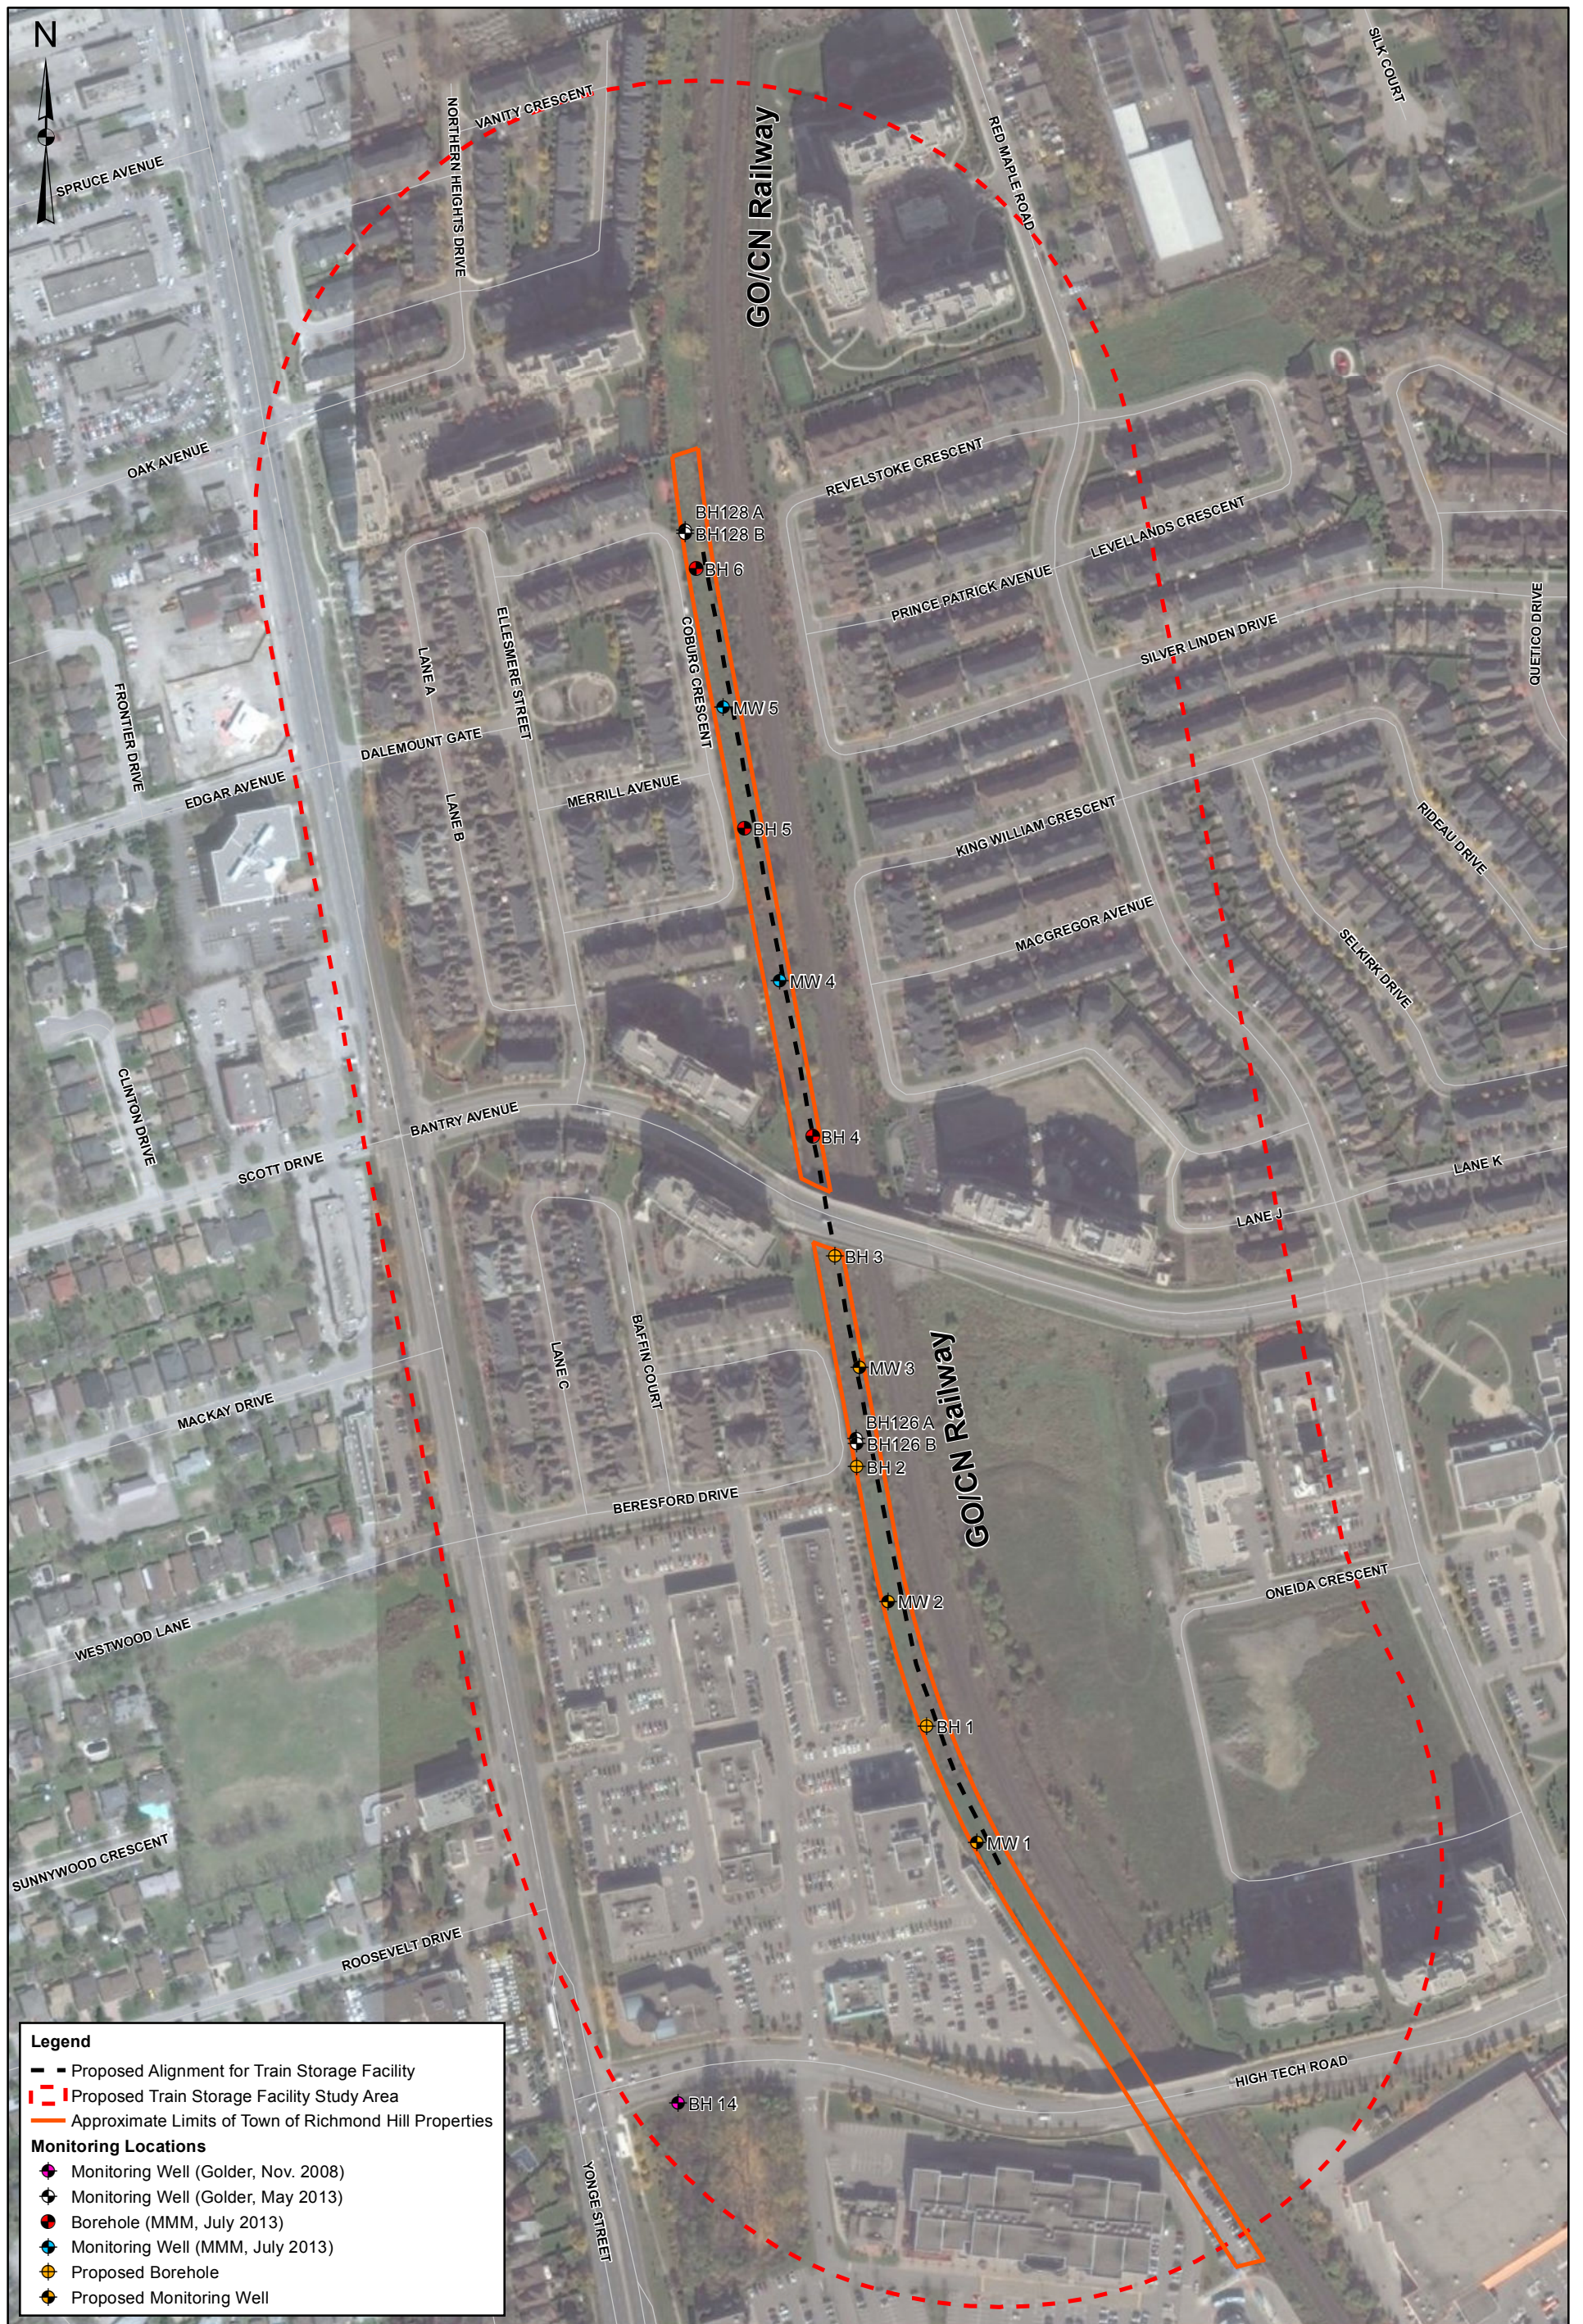
MMM Group Limited (MMM) was retained by the Toronto Transit Commission and York Region Rapid Transit Corporation to complete a groundwater assessment for a proposed 14-car Train Storage Facility (TSF) in the vicinity of the Richmond Hill Centre. The TSF is proposed to be built approximately 0.6 km north of High Tech Road to 0.1 km north of Edgar Avenue and 25 m west of the existing CN/GO railway corridor. The Study Area for a groundwater assessment is an area within a 250-m radius of the proposed TSF (herein referred to as the “Study Area”), shown in **Figure 1**.

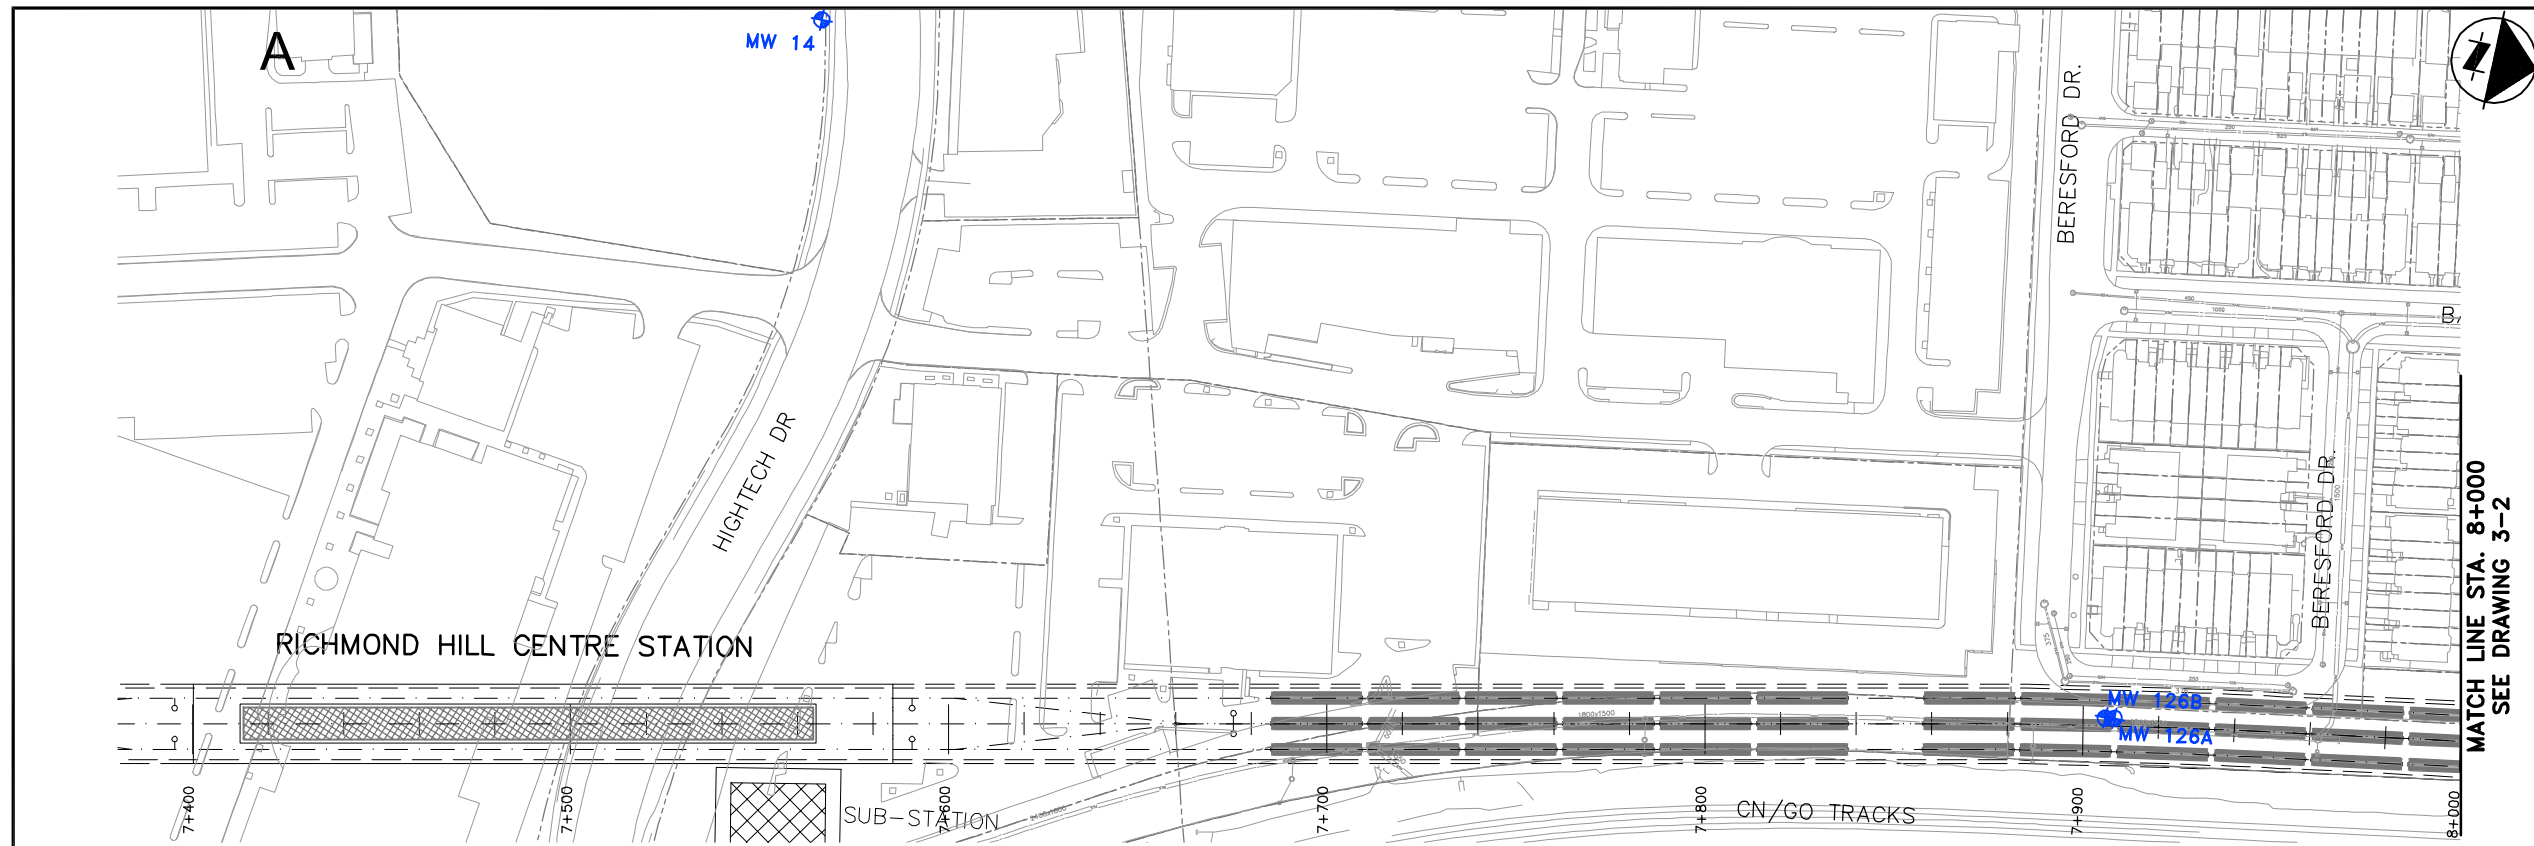
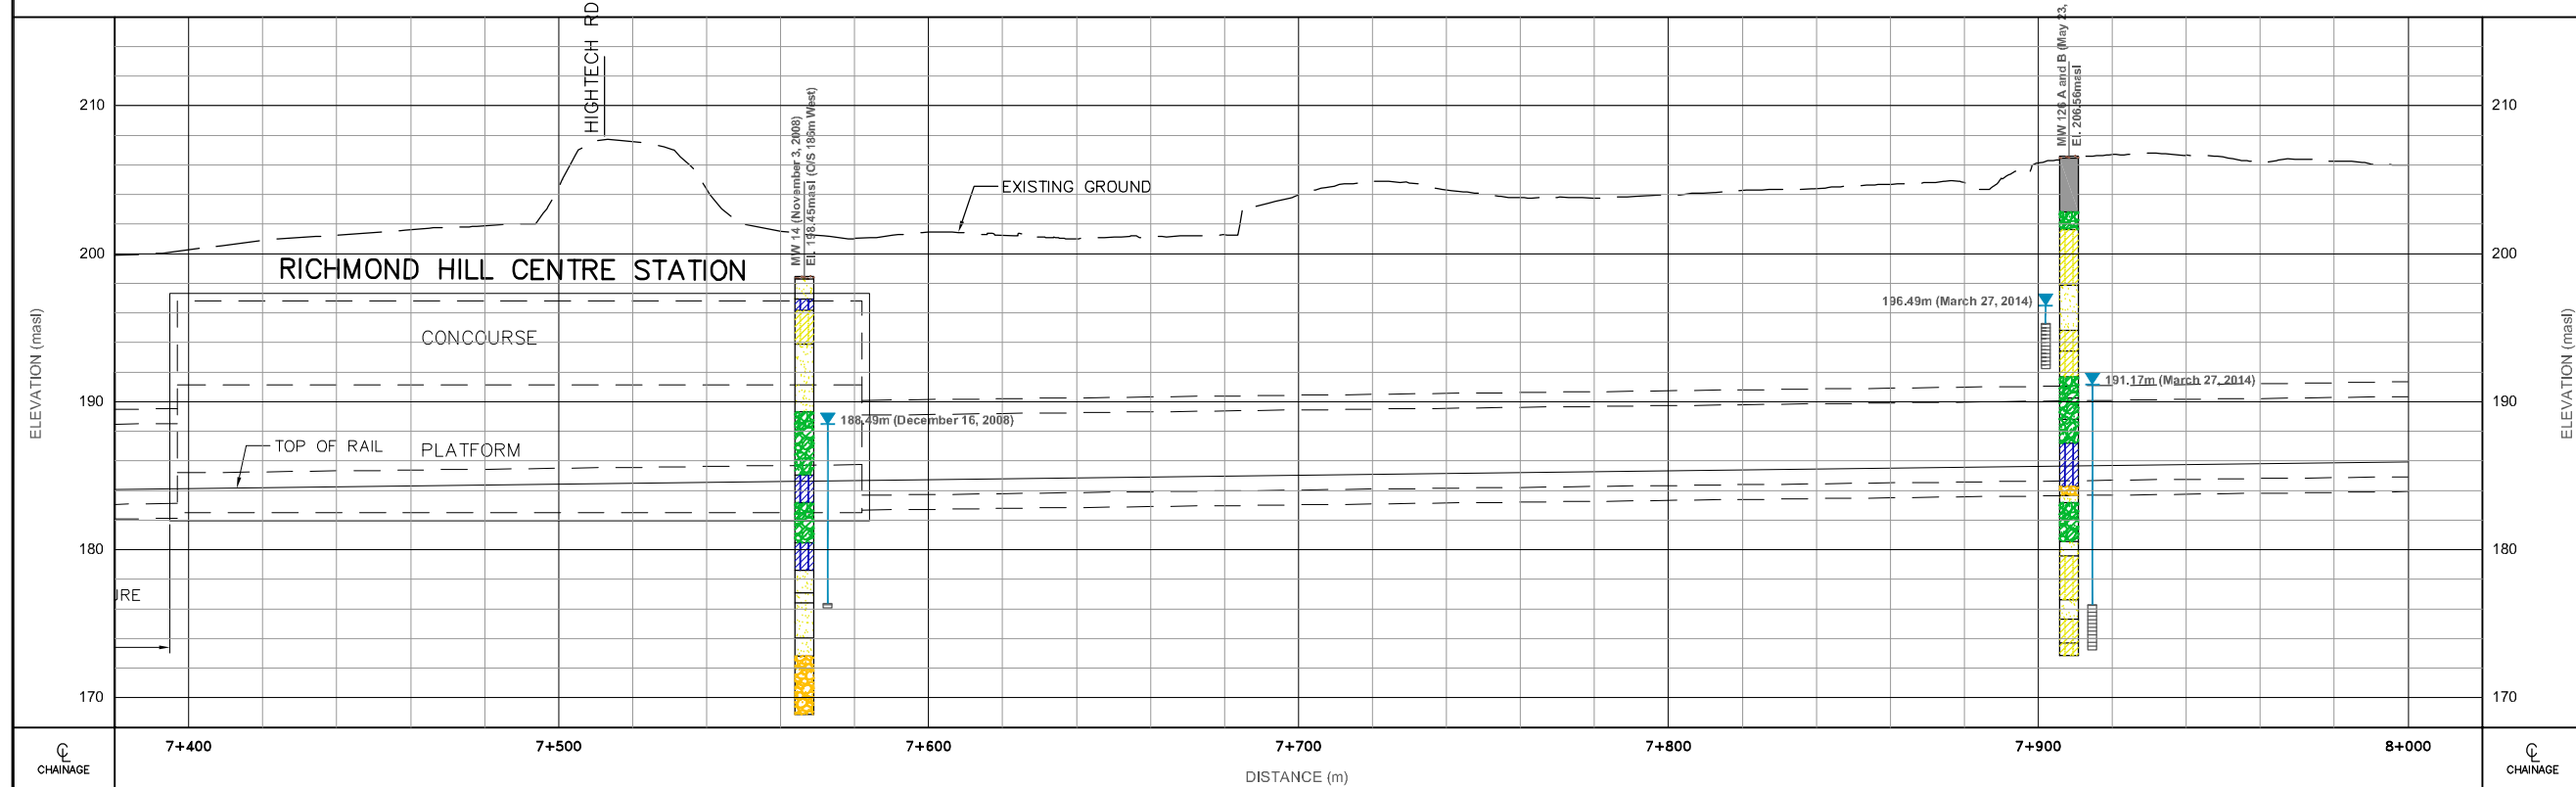
April 2014
PROJECT: 3277670
FIGURE: 3-1

HYDROGEOLOGICAL CROSS-SECTION A-A' AND CONCEPTUAL DESIGN OF TRAIN STORAGE FACILITY
YONGE SUBWAY EXTENSION EPR ADDENDUM
RICHMOND HILL, ONTARIO

Only limited information regarding existing local hydrogeological conditions in the Study Area is currently available. As shown in **Figures 3-1** and **3-2**, glacial till deposits are present in the upper portion of the Study Area. These deposits are interbedded with deposits of silty clay to clayey silt. Loose to dense granular soils containing sand and gravel appear to be present beneath till at least in the southern portion of the Study Area (**Figure 3-1**).

MMM measured groundwater levels in the wells present in the Study Area on March 27, 2014 (see **Table 1**). As can be seen from **Table 1** and **Figures 3-1** and **3-2**, the shallow groundwater is present at the depths of 9.0 to 10.9 mbgs within the Study Area. The deeper groundwater unit water levels were found to be present at the depths of 16.3 to 16.8 mbgs in the Study Area. Additional monitoring wells are required to be installed to understand the flow direction of shallow and deep groundwater in the Study Area.

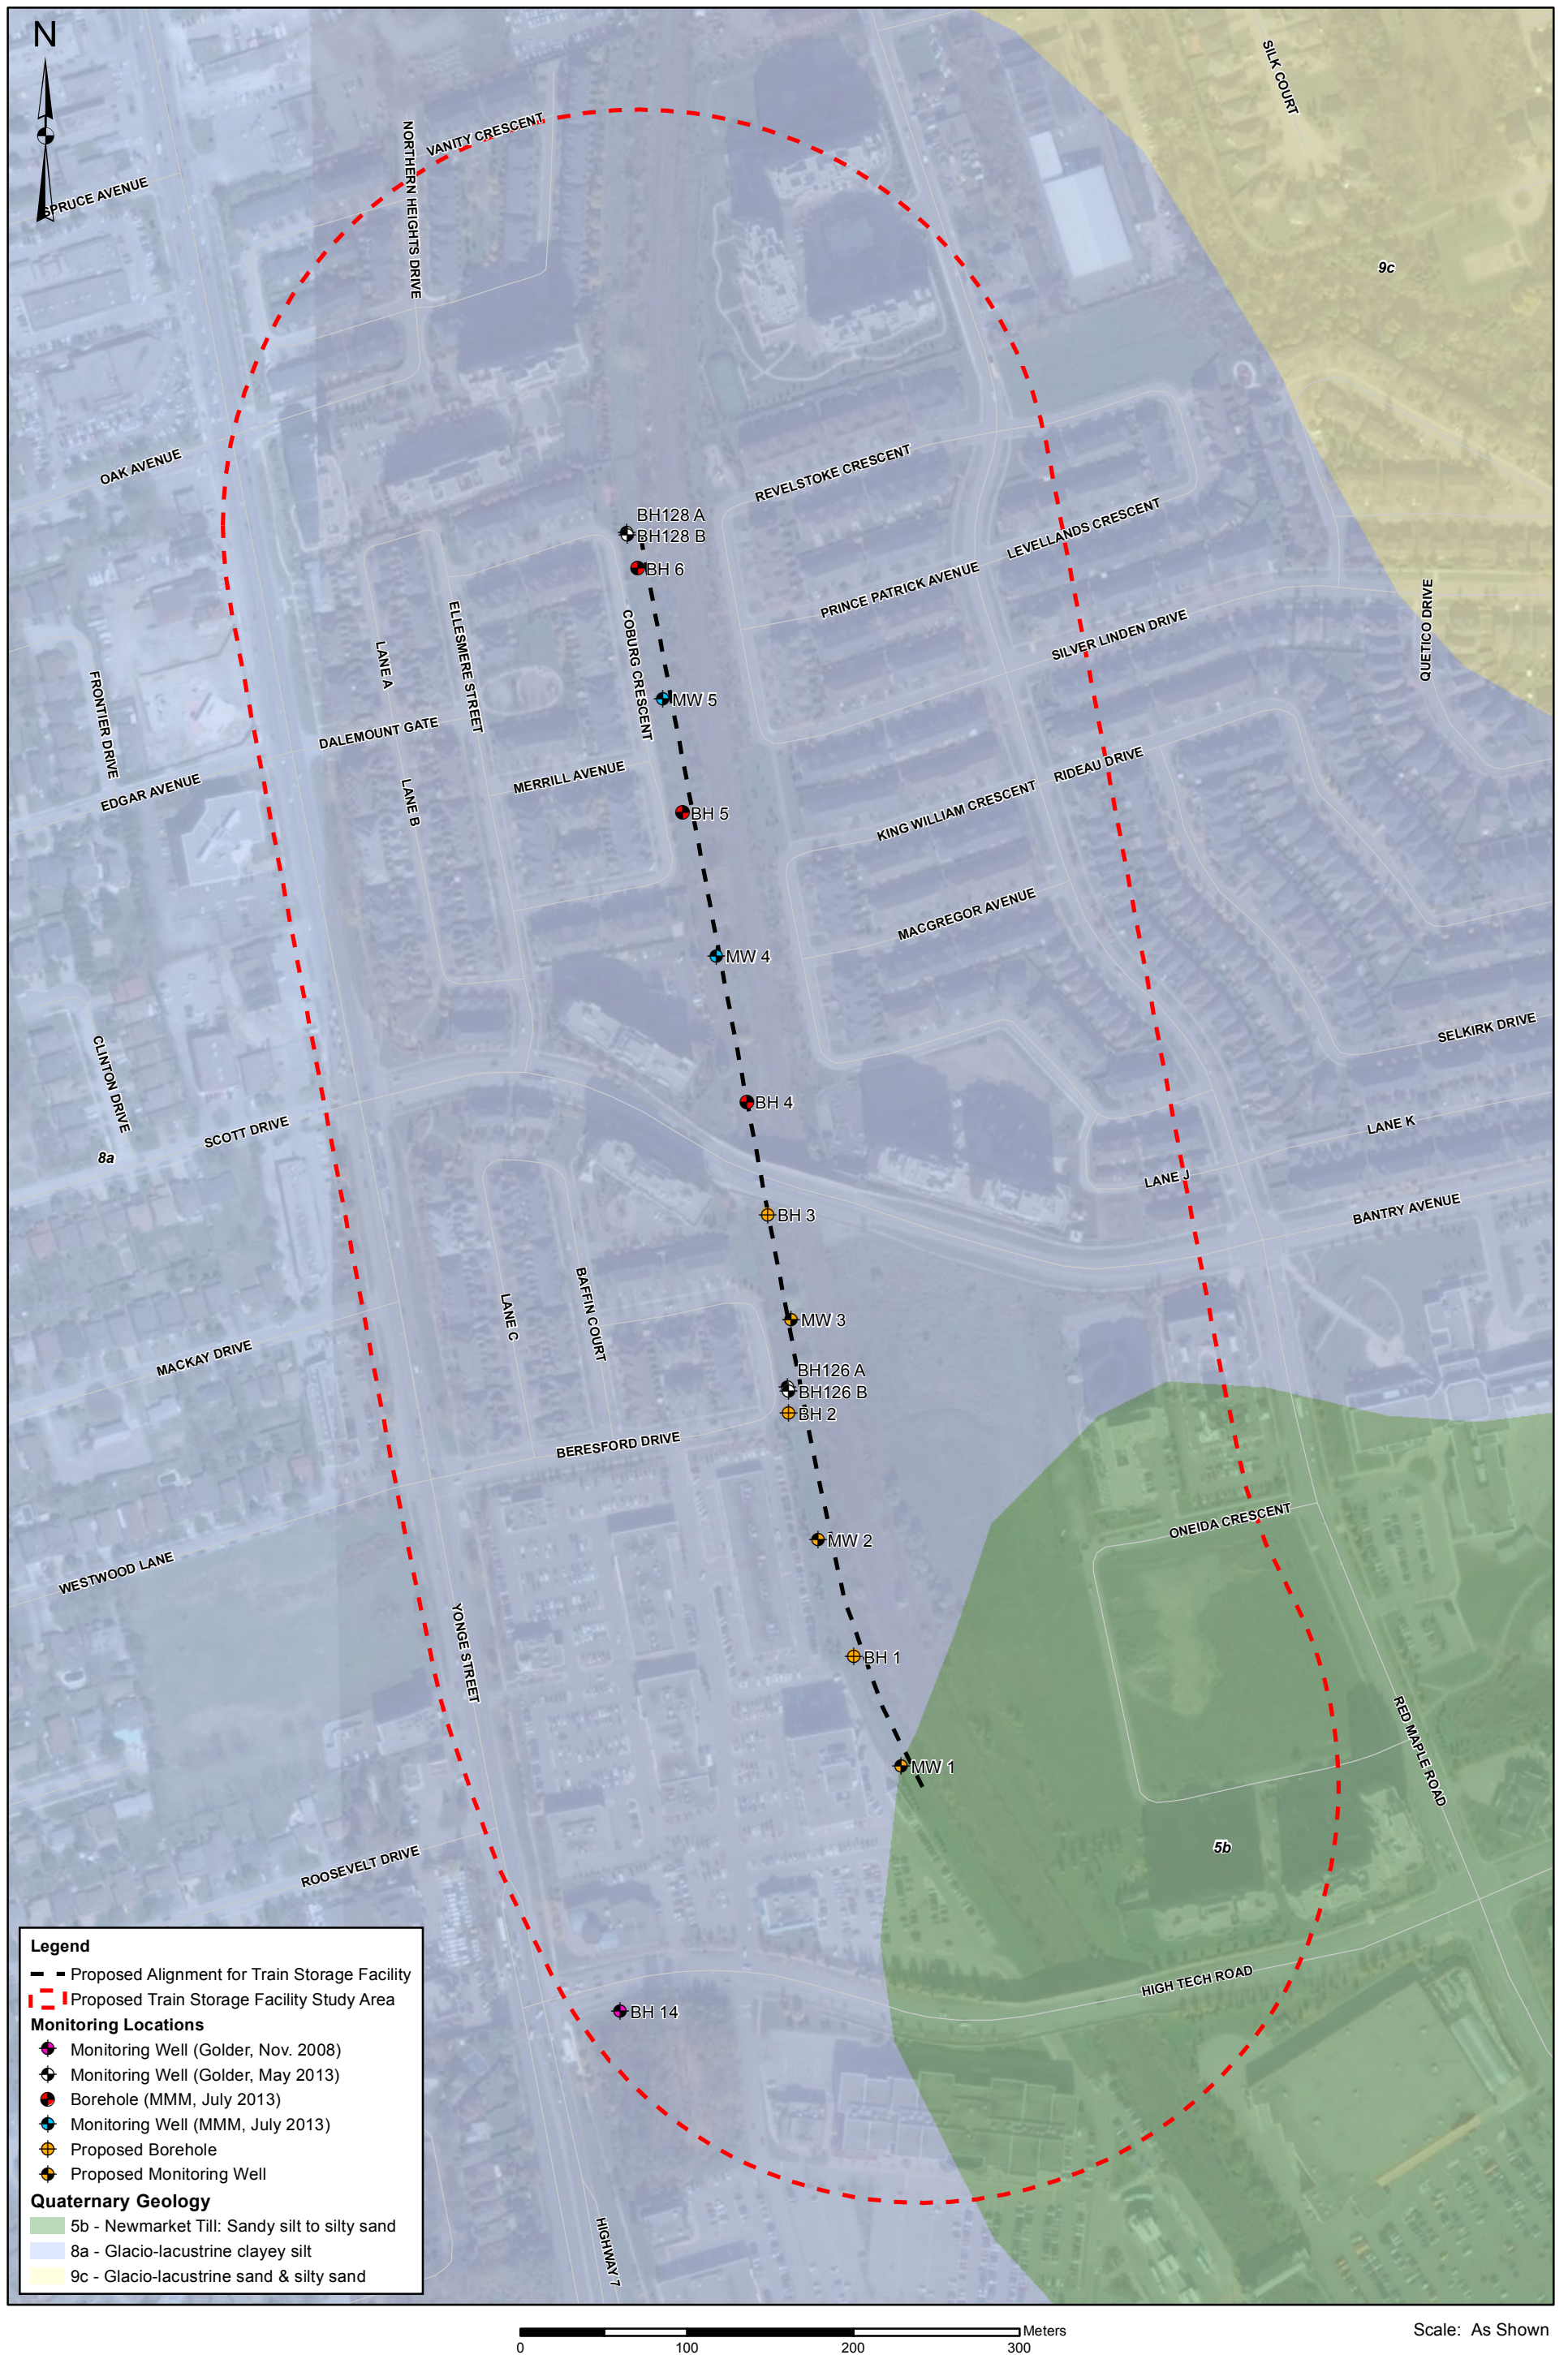
April 2014
 PROJECT: 3277670
 FIGURE: 3-2

As shown in **Figure 3-2**, clayey silt to silty clay till is present below the fill layer at the depths ranging from 2.2 to 9.5 mbgs and from 13.3 to 21.0 mbgs. Clayey silt till in the central portion is present at the depths of 3.7 to 4.9 mbgs, 14.9 to 16.3 mbgs and 17.8 to 19.4 mbgs. It appears that these deposits may potentially be present at the depths of 9.2 to 13.4 mbgs and 15.2 to 18.0 mbgs in the southern portion the Study Area (**Figure 3-1**). The till seems to be interbedded with deposits of silty clay to clayey silt at shallow depths down to 13.3 m in the northern portion of the Study Area (**Figure 3-2**). Silty clay to clayey silt deposits was found to be present at the depth of 19.4 to 22.3 mbgs in the central portion and below 20.9 mbgs in the northern portion of the Study Area. These deposits are interpreted to be present at the depth of 13.4 to 15.2 mbgs and of 18.0 to 19.8 mbgs in the southern portion of the Study Area (**Figure 3-1**).

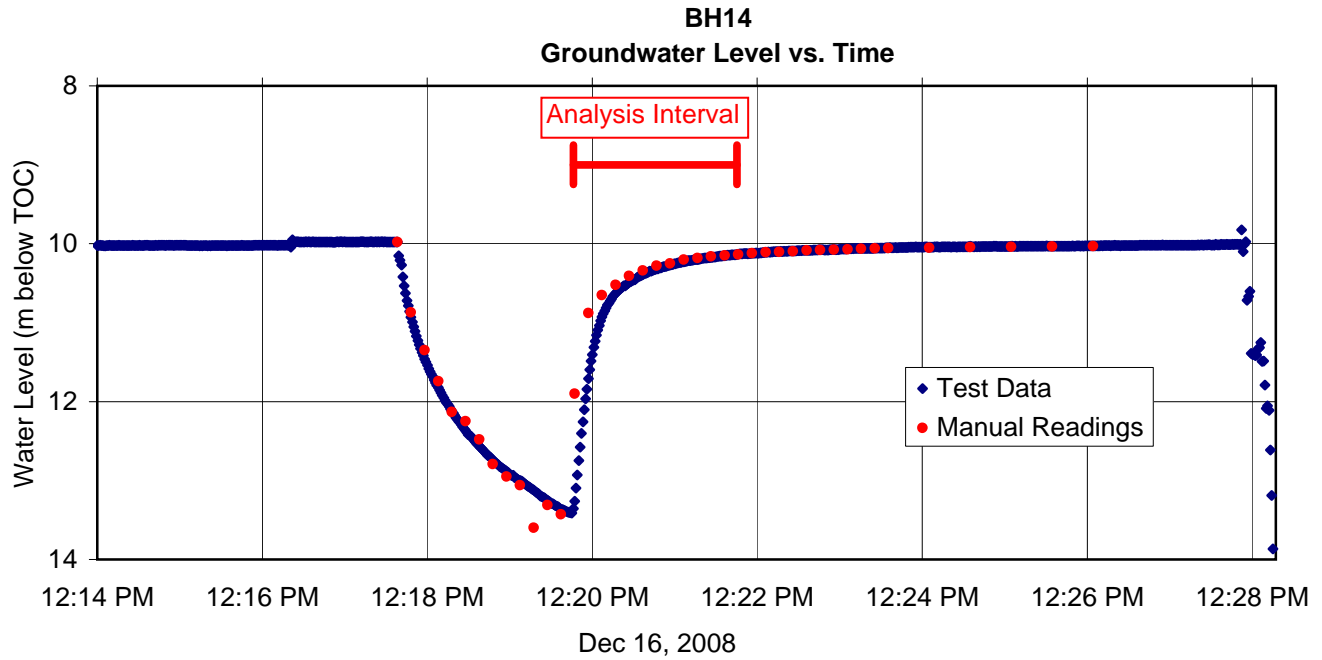
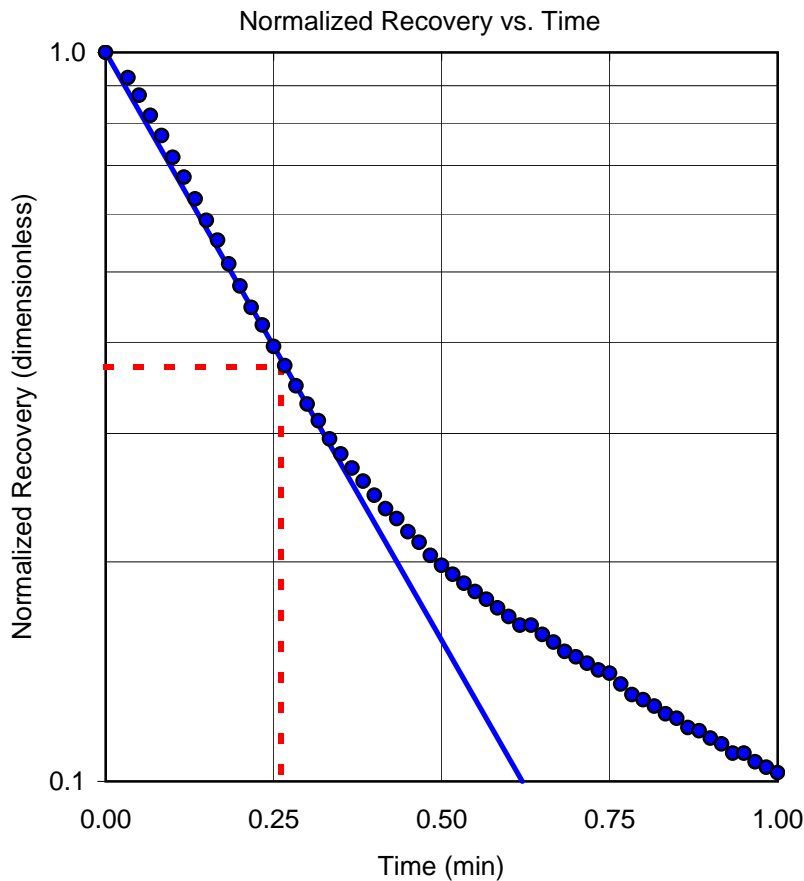
FIGURE B9

Screened Interval
154.22 to 149.97 masl
Sandy Silt to Sand and Silt

Time Lag (T_0) = 0.3 min
Screen Length (L) = 5.19 m
Well Radius (r) = 0.0254 m
Hole Radius (R) = 0.076 m

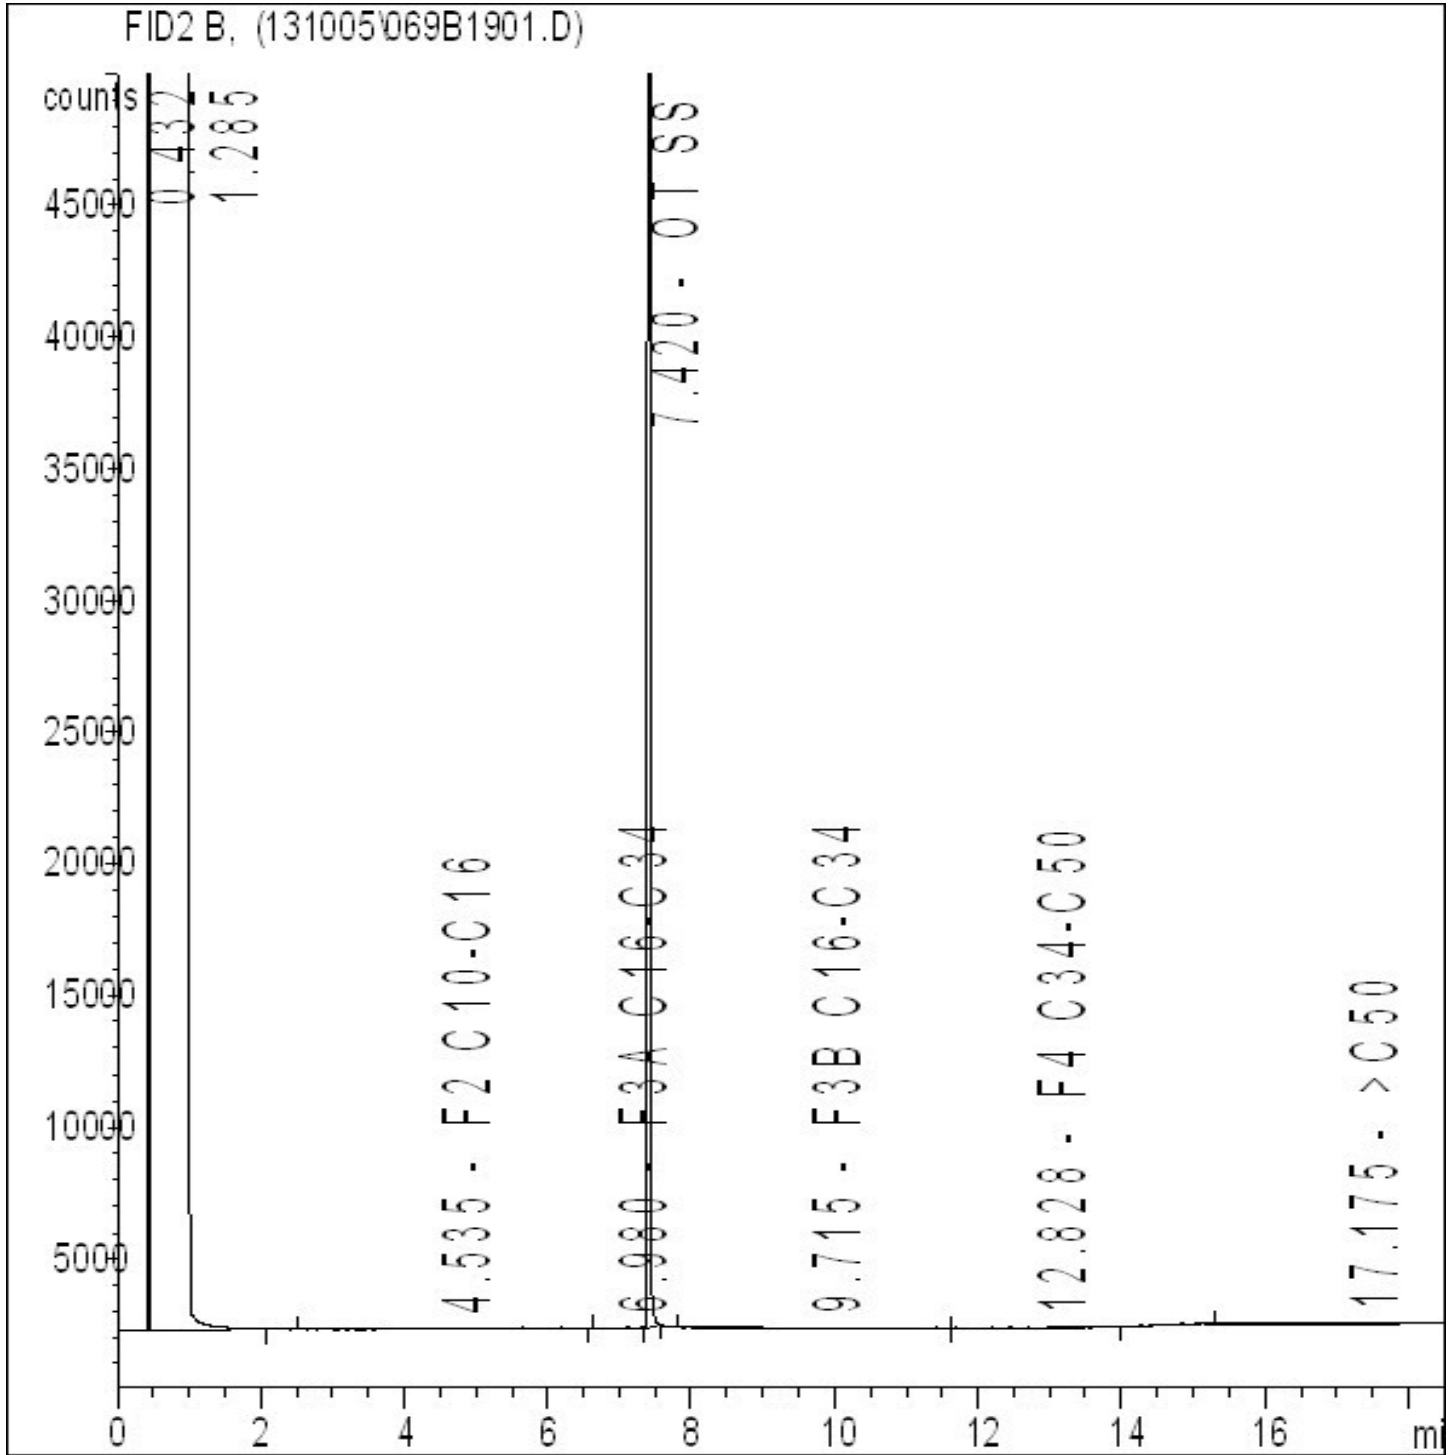
Petroleum Hydrocarbons F2-F4 in Water Chromatogram
